Re: Principal Threat Wastes Technical Memorandum
Sauget Area 2
Sauget, Illinois

Subject: **Principal Threat Wastes Technical Memorandum-Revised**

This technical memorandum summarizes existing data regarding the presence of non-aqueous phase liquid (NAPL) and buried drums at Sauget Area 2 (SA2) and provides an evaluation of whether the NAPL or buried drums containing liquid waste materials would constitute principal threat wastes.

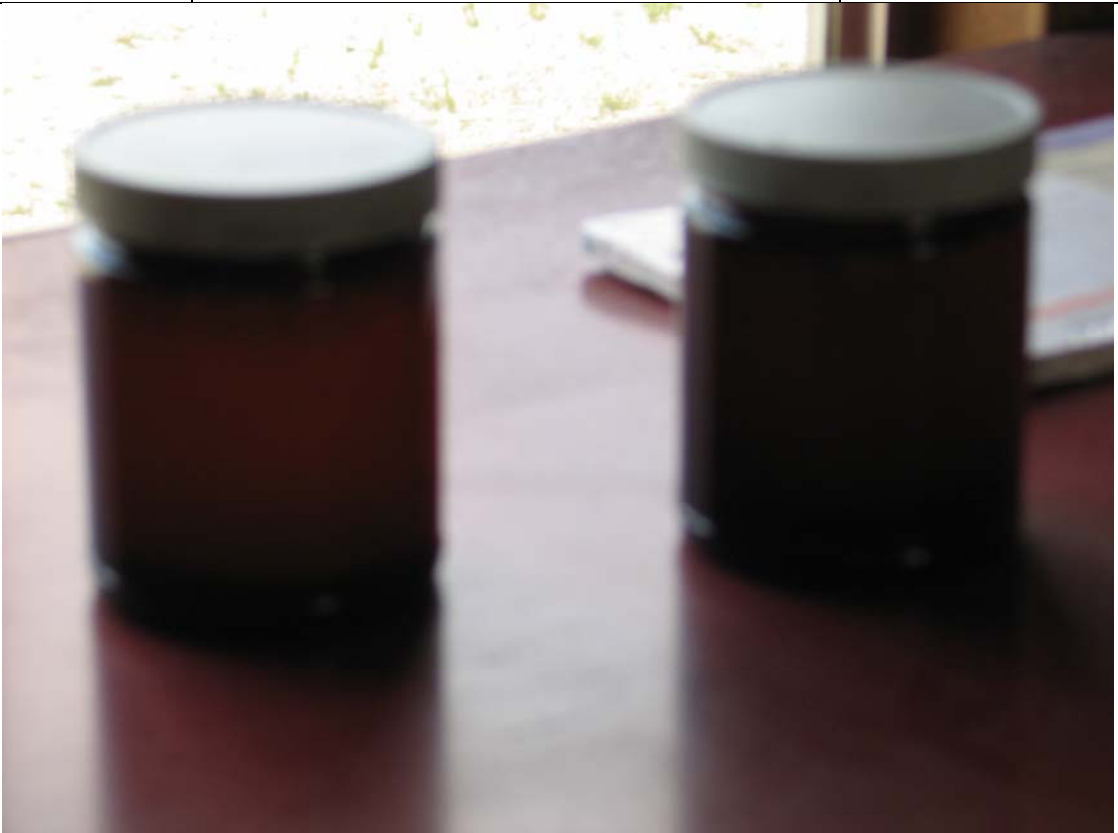
Client Name: Sauget Area 2 Sites Group		Site Location: Sauget, Illinois	Project No. 21561683
Photo No. 5	Date: 7/26/06

Description: Leach-P-1 Sample jars placed on windowsill near window to attempt to see the separation between L-NAPL and water, and between the water and D-NAPL.

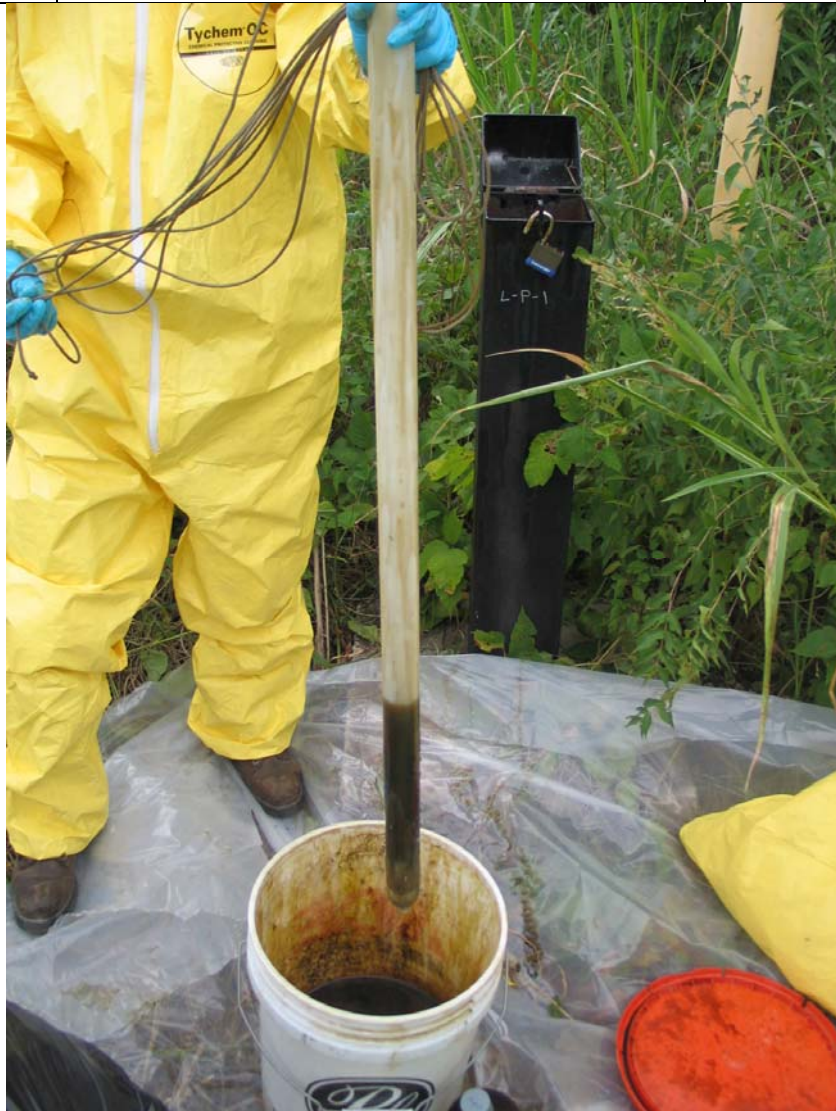
Description:
Leach-P-1
Bailer covered in NAPL
on first attempt to
collect a sample.

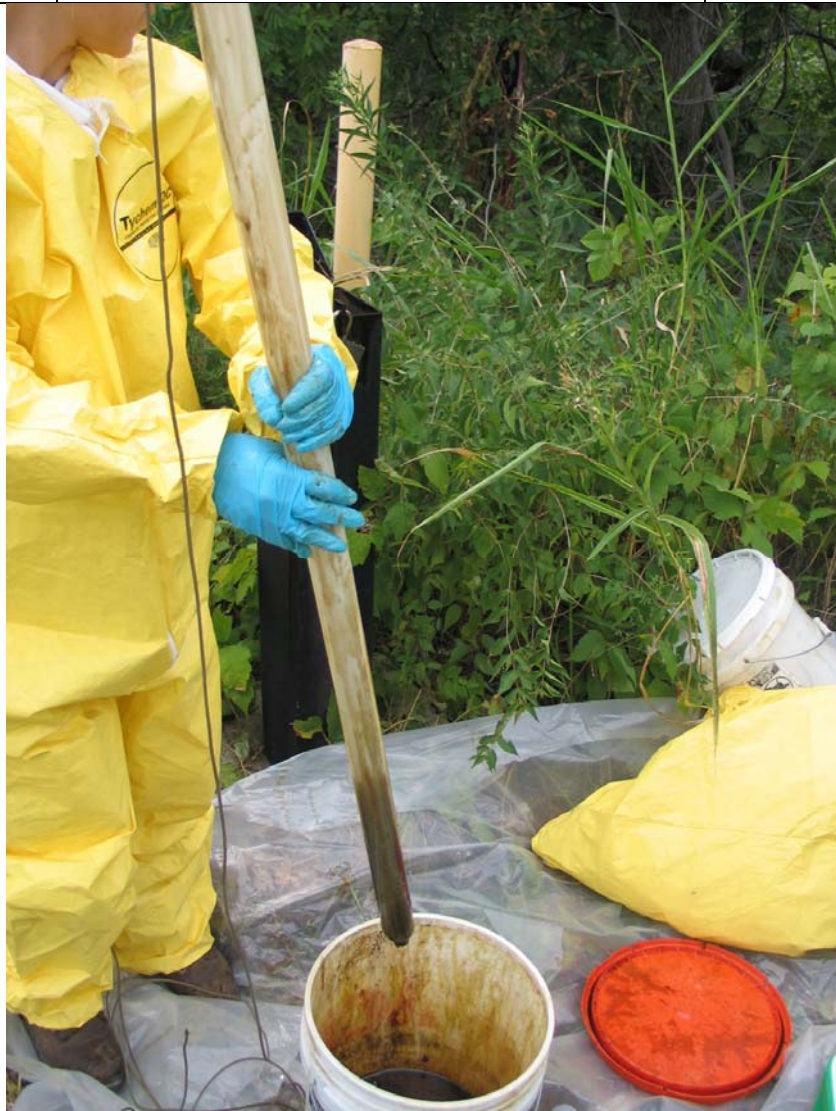
Photo No. 12	Date: 7/27/06
-------------------------------	-------------------------

Description:
Leach-P-1
Bailer covered in NAPL
on first attempt to
collect a sample.

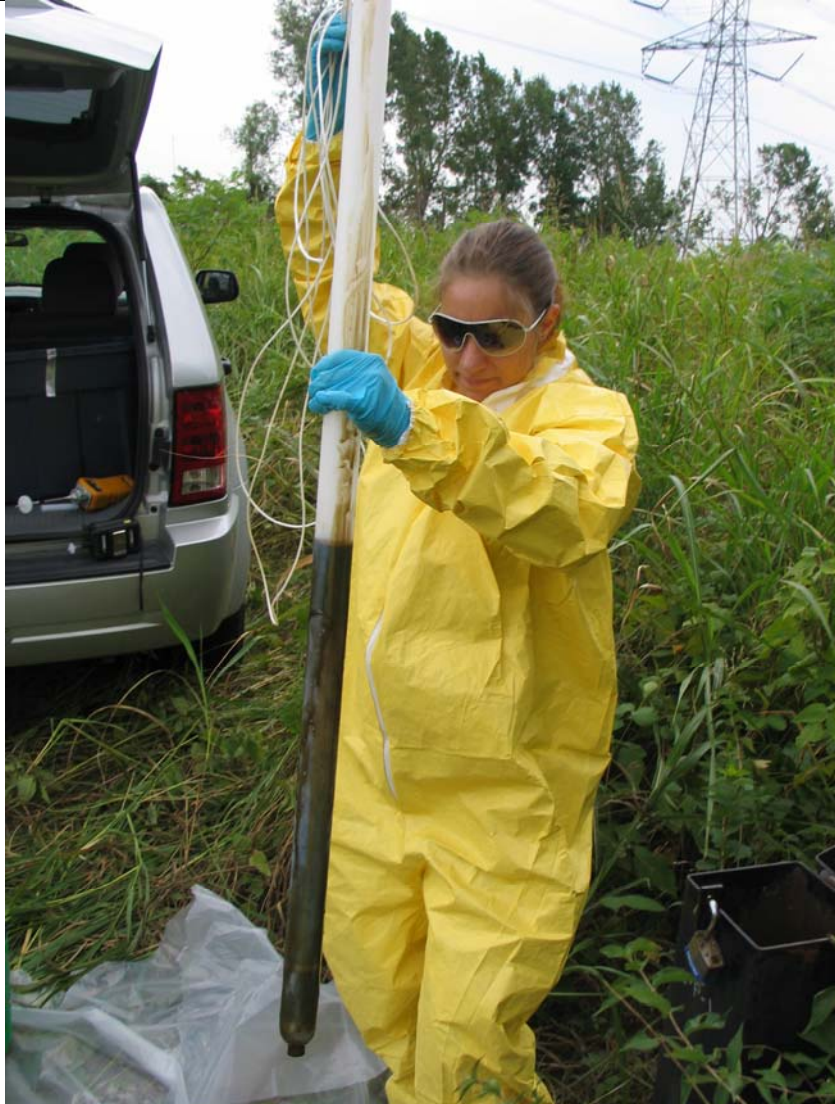
Client Name: Sauget Area 2 Sites Group		Site Location: Sauget, Illinois	Project No. 21561683
Photo No. 13	Date: 7/27/06

Description: Leach-P-1 Bailer covered in NAPL on second attempt to collect sample.

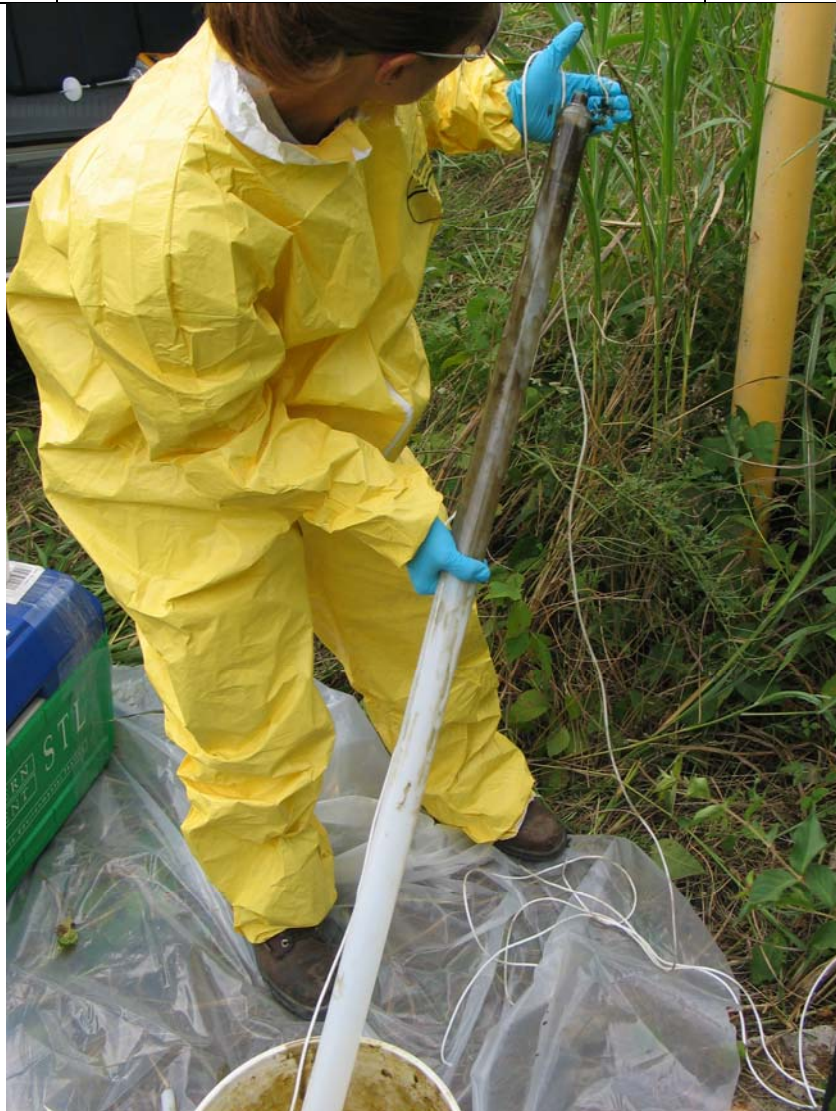
Description:
Leach-P-1
Bailer covered in NAPL,
on third attempt to
collect sample.

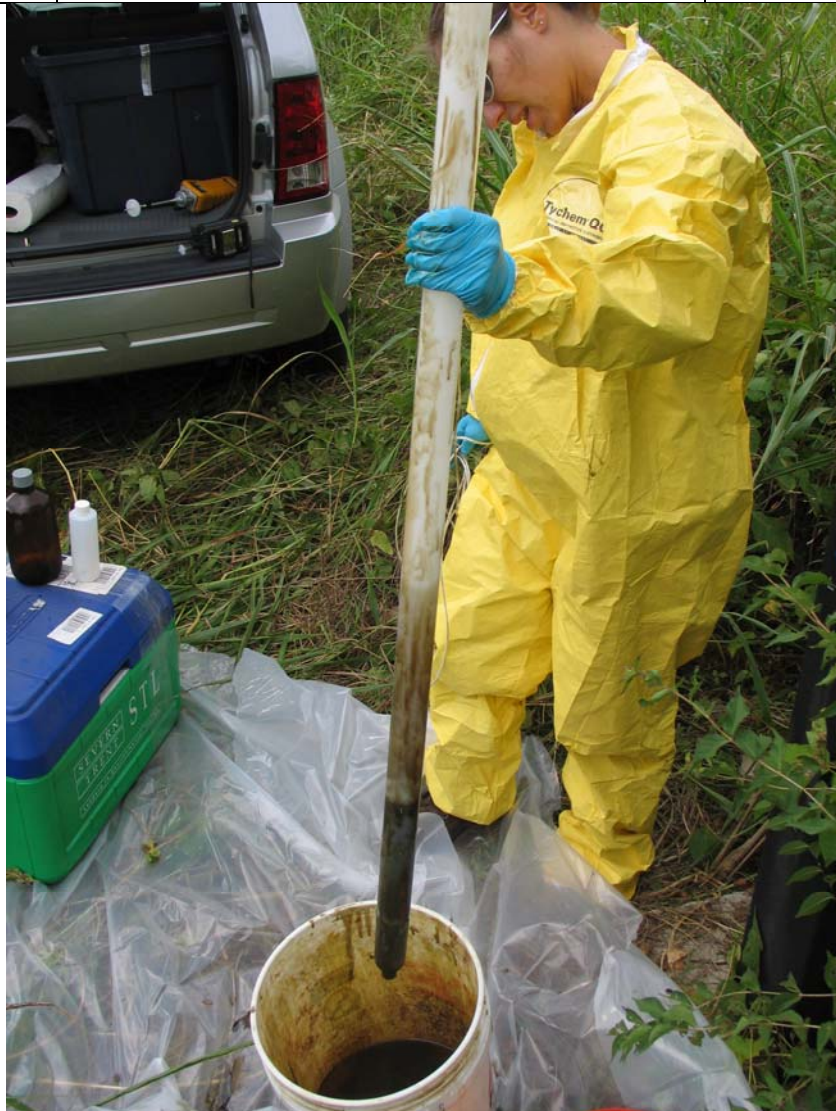
Photo No. 15	Date: 7/27/06
-------------------------------	-------------------------

Description:
Leach-P-1
Bailer covered in NAPL

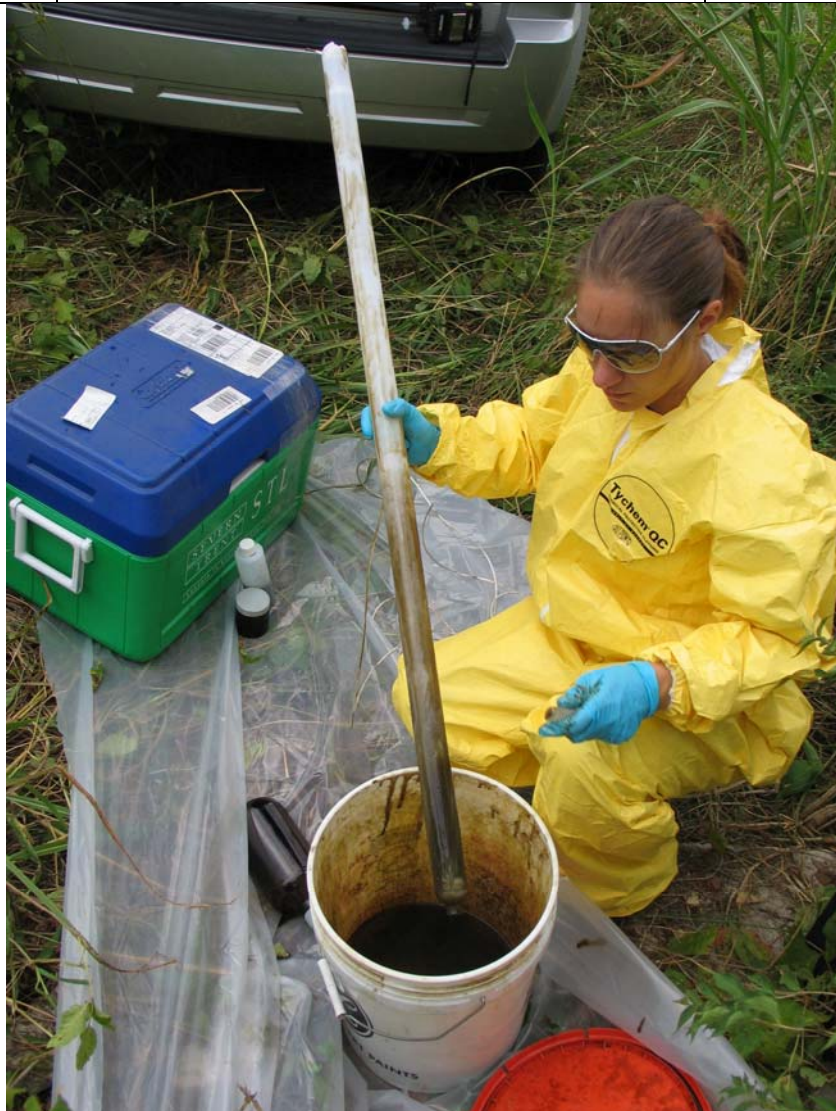
Photo No. 16	Date: 7/27/06
Description: Leach-P-1 Bailer covered in NAPL.

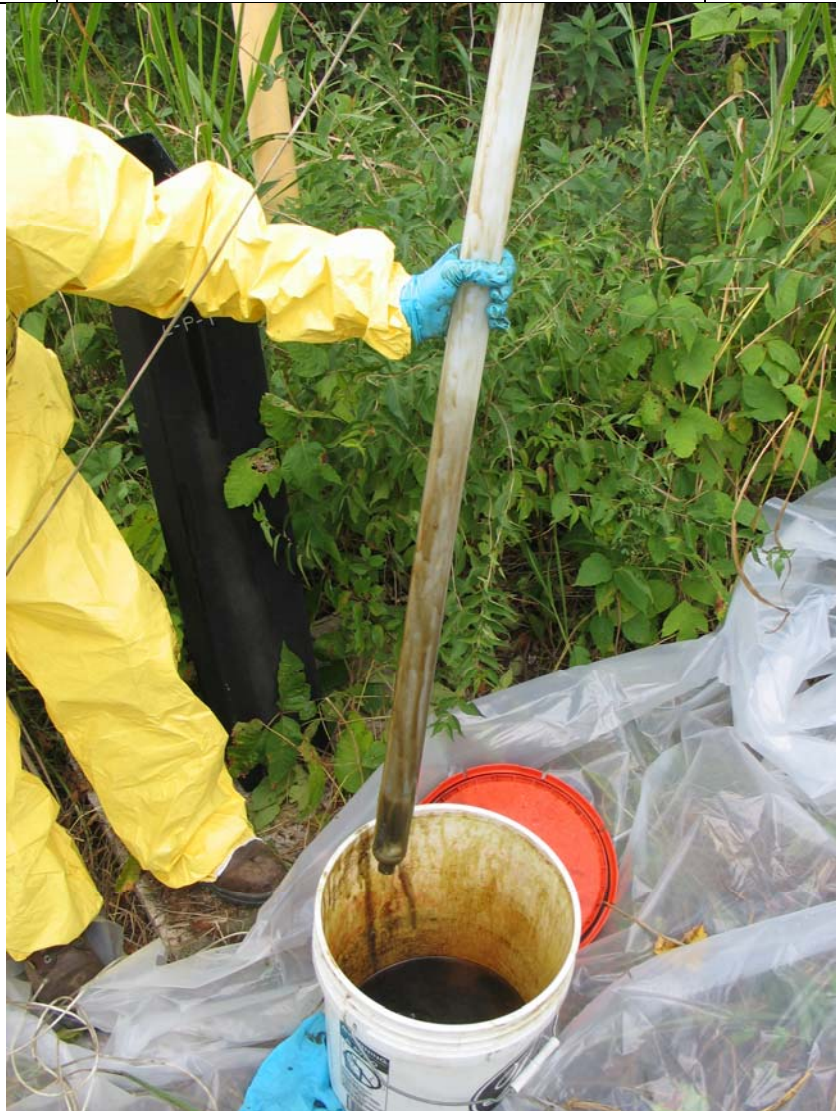
Description:
Leach-P-1
Bailer covered in NAPL.
Unable to collect
sample.

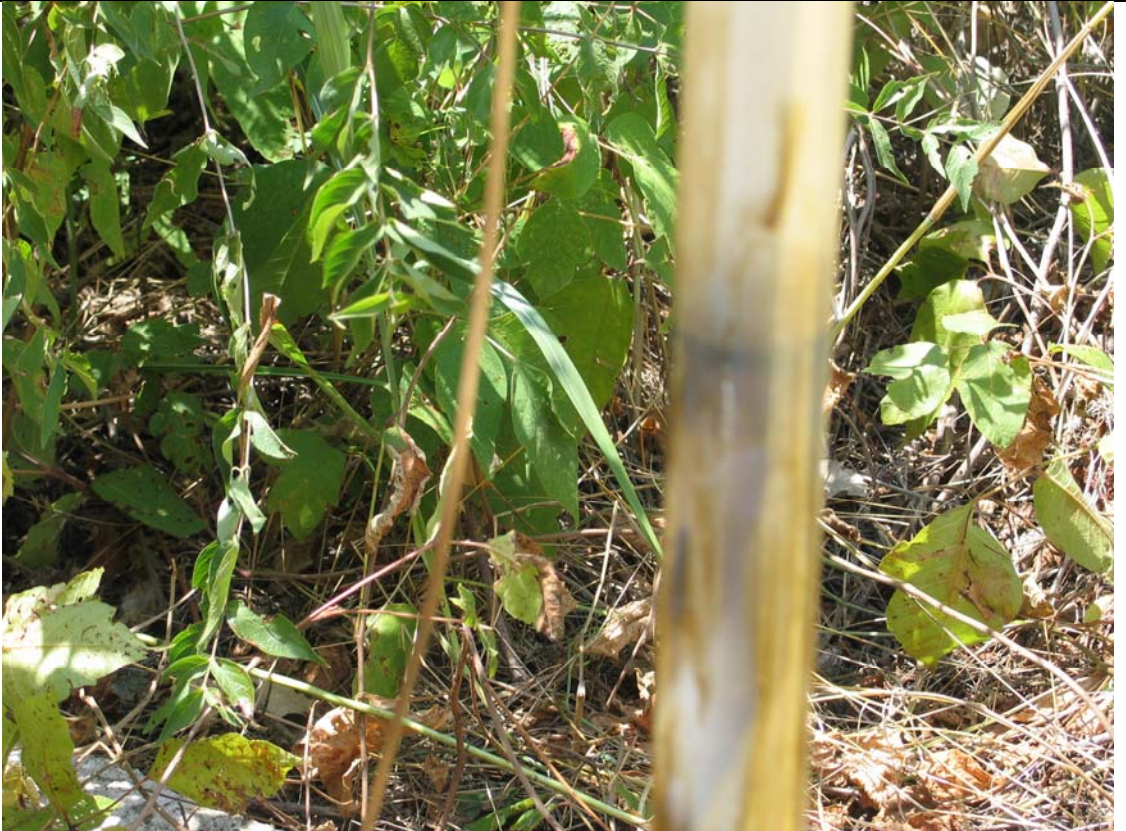
Client Name: Sauget Area 2 Sites Group		Site Location: Sauget, Illinois	Project No. 21561683
Photo No. 21	Date: 7/27/06

Description: Leach-P-1

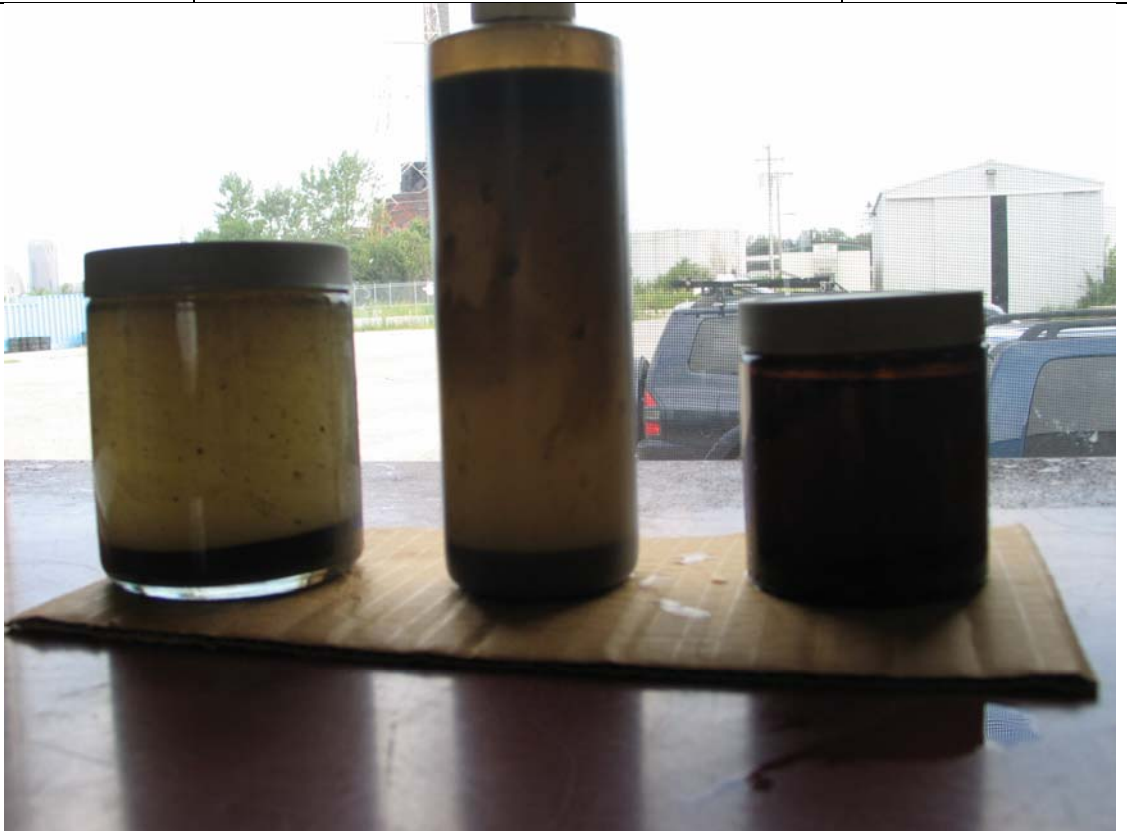
Client Name: Sauget Area 2 Sites Group		Site Location: Sauget, Illinois	Project No. 21561683
Photo No. 25	Date: 7/27/06

Description: Leach-P-1 Sample jars placed on windowsill near window to attempt to see the separation between L-NAPL and water, and between the water and D-NAPL.

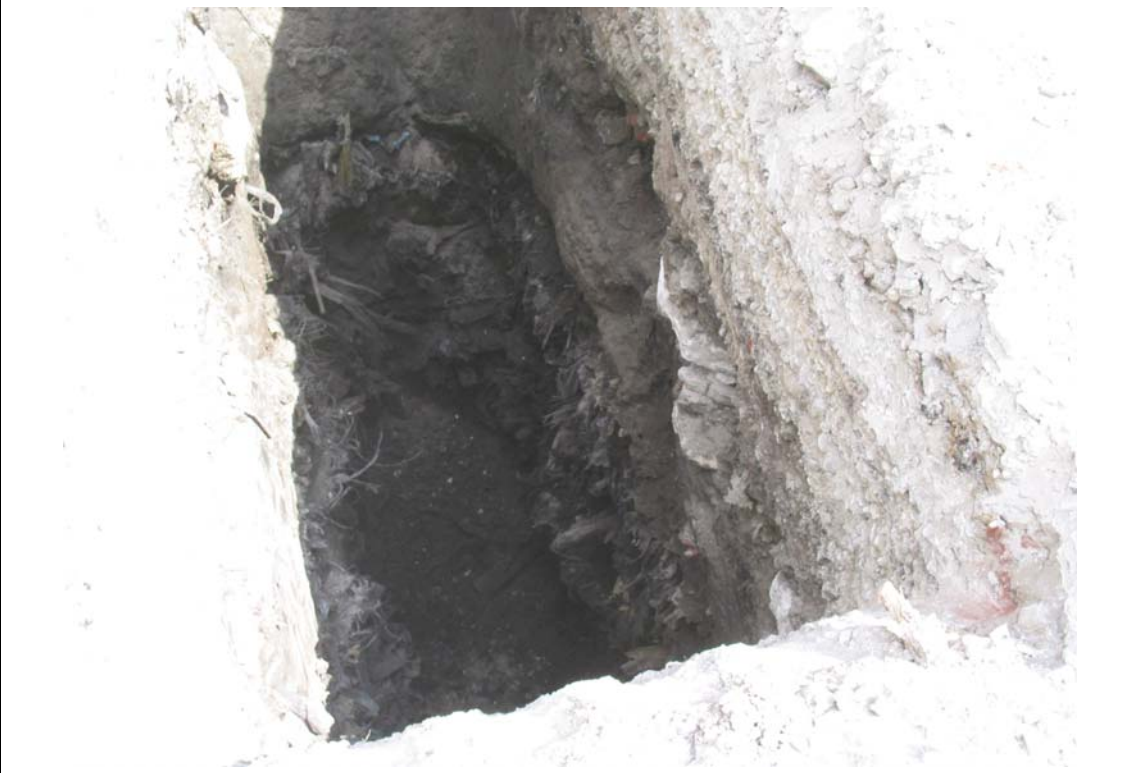
Client Name: Sauget Area 2 Sites Group		Site Location: Sauget, Illinois	Project No. 21561510
Photo No. 9	Date: 6/2/05

At Anomaly Trench AT-Q-29 in Site Q Central, a crushed drum was encountered with potential NAPL residue on the inside walls of the drum, which was located approximately 16 feet bgs and at the western edge of the trench. In our opinion, tar-like materials or other high viscosity liquids such as was found in AT-Q-29 are not considered liquids constituting principal threat wastes. These materials are not highly mobile and would be expected to be retained in the fine-grained soils that characterize the shallow hydrogeologic unit at SA2. This potential NAPL residue will not be considered principal threat waste.

Description: AT-Q-29 6-2-05, using excavator with longer reach

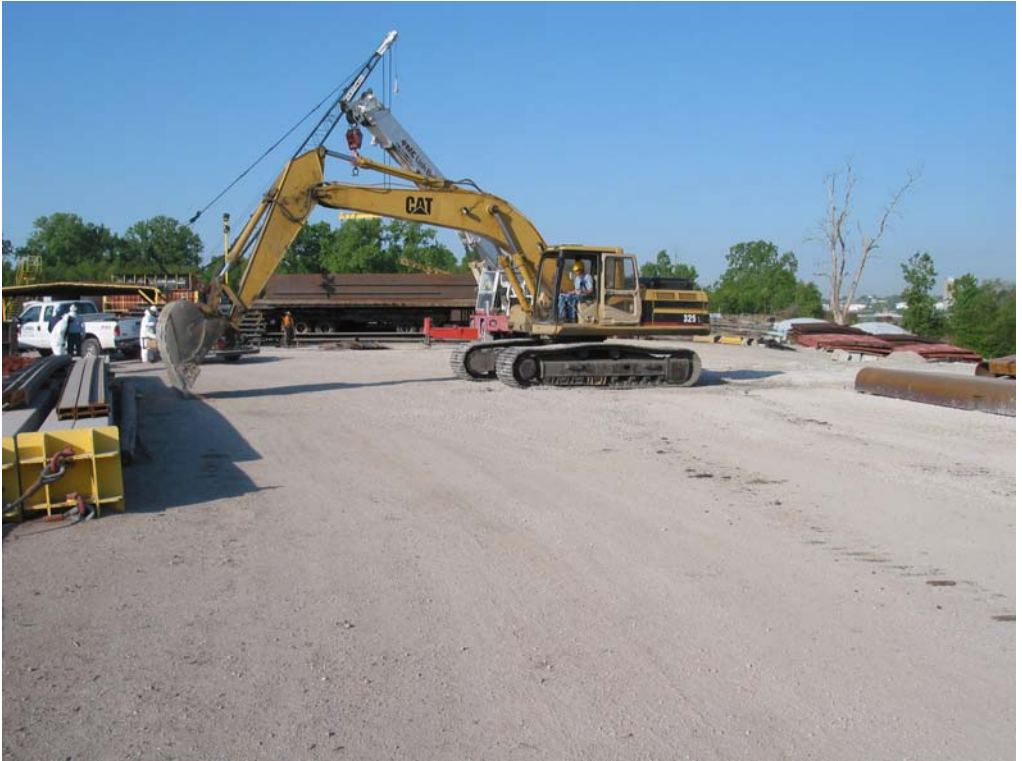
Client Name: Sauget Area 2 Sites Group		Site Location: Sauget, Illinois	Project No. 21561510
Photo No. 14	Date: 5/6/05

Description: AT-Q-29 before trenching activities

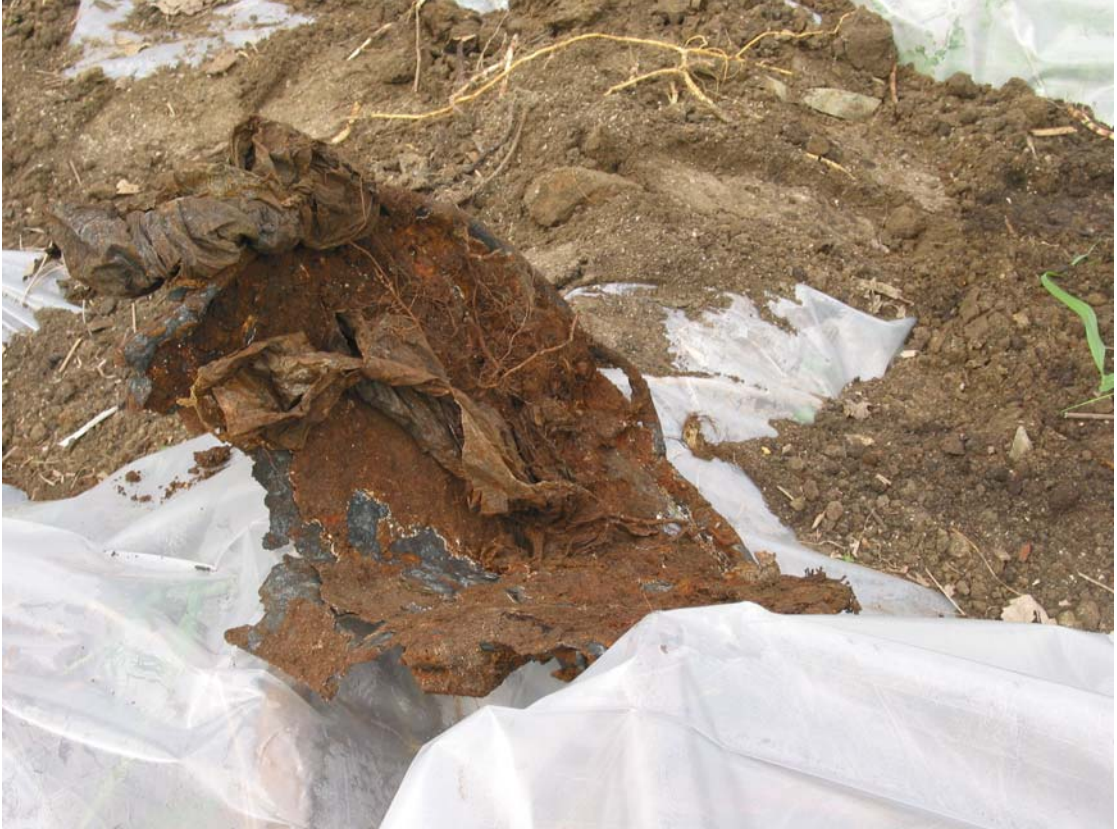
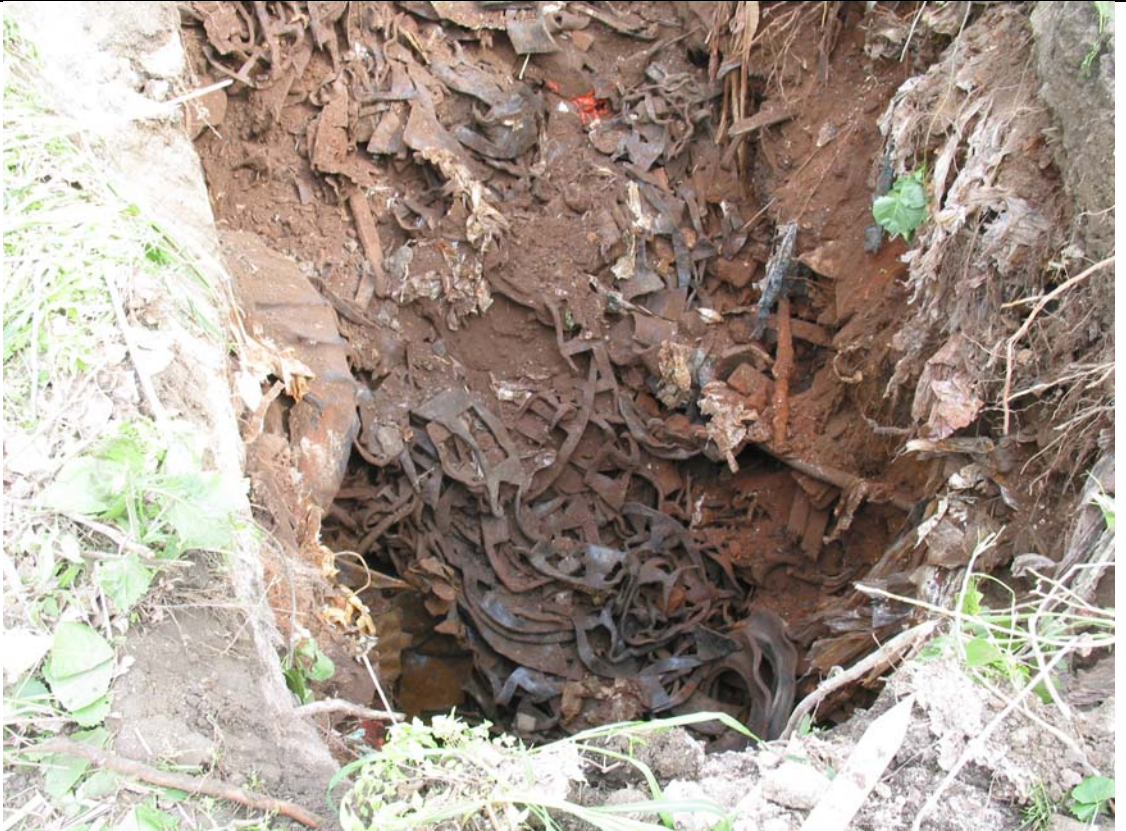
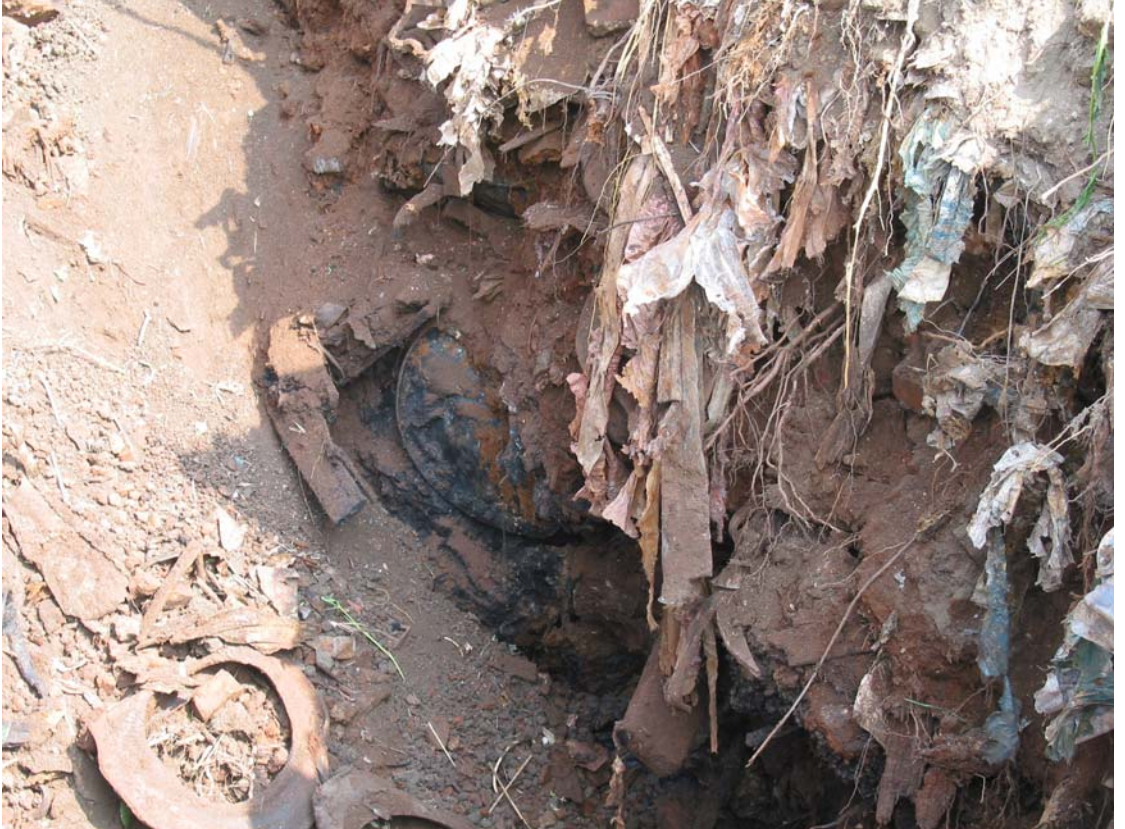
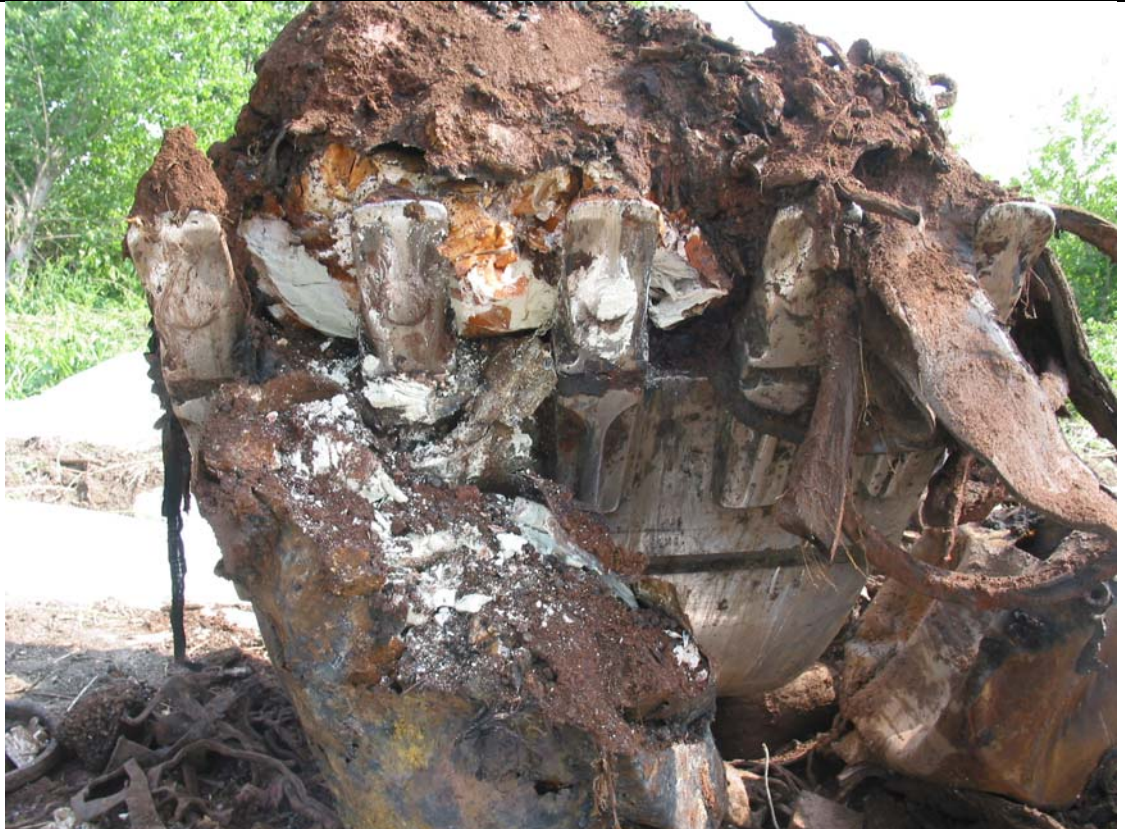
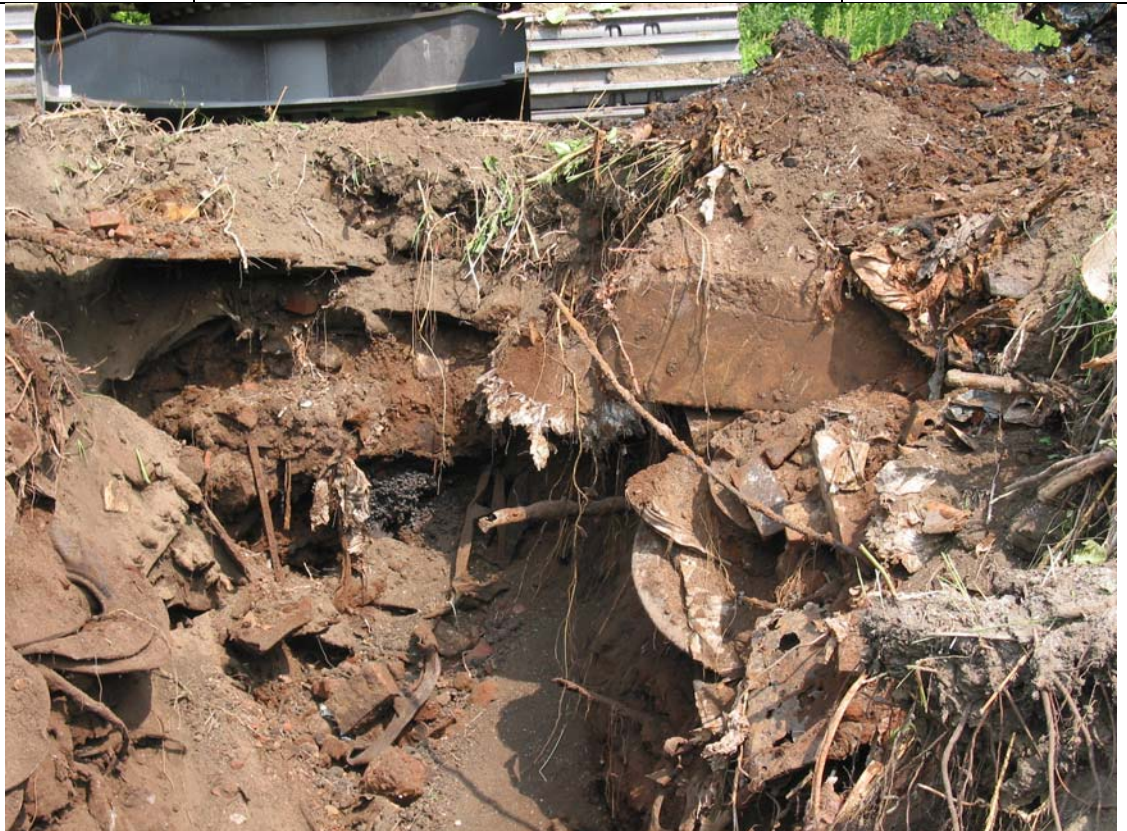
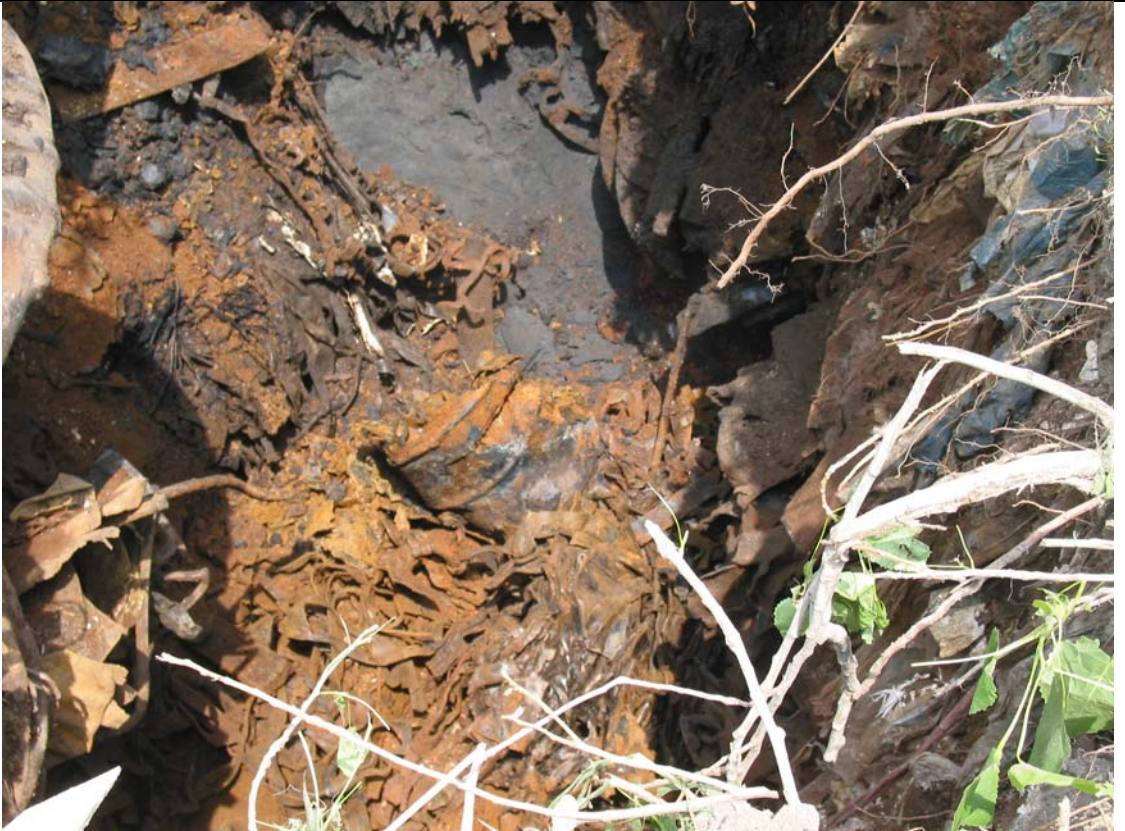
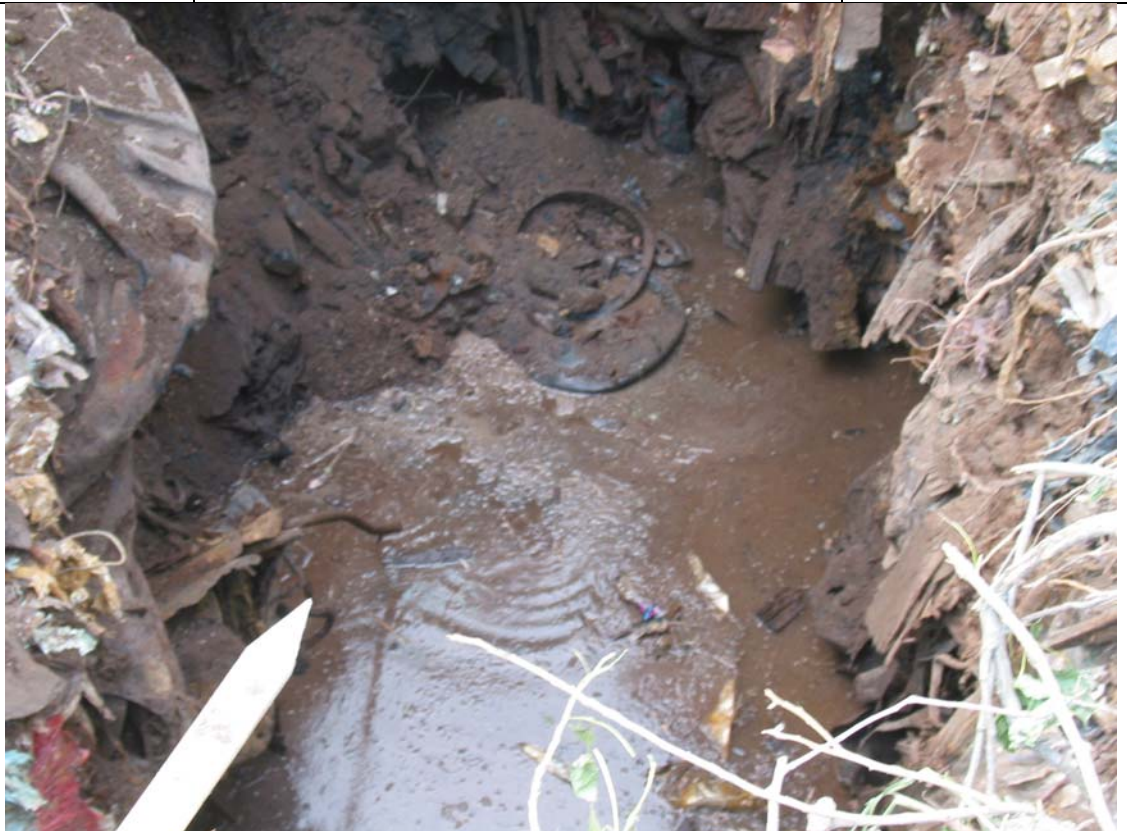
* At Site Q South (AT-Q-35) two intact drums were discovered, one of which was leaking a liquid. Since the two drums were found in close proximity to each other, to be conservative both were considered to contain liquid and be principal threat waste. Four additional drums were partially uncovered; however, it was not determined if the four partially uncovered drums were intact or contained liquid.

Description: AT-Q-35

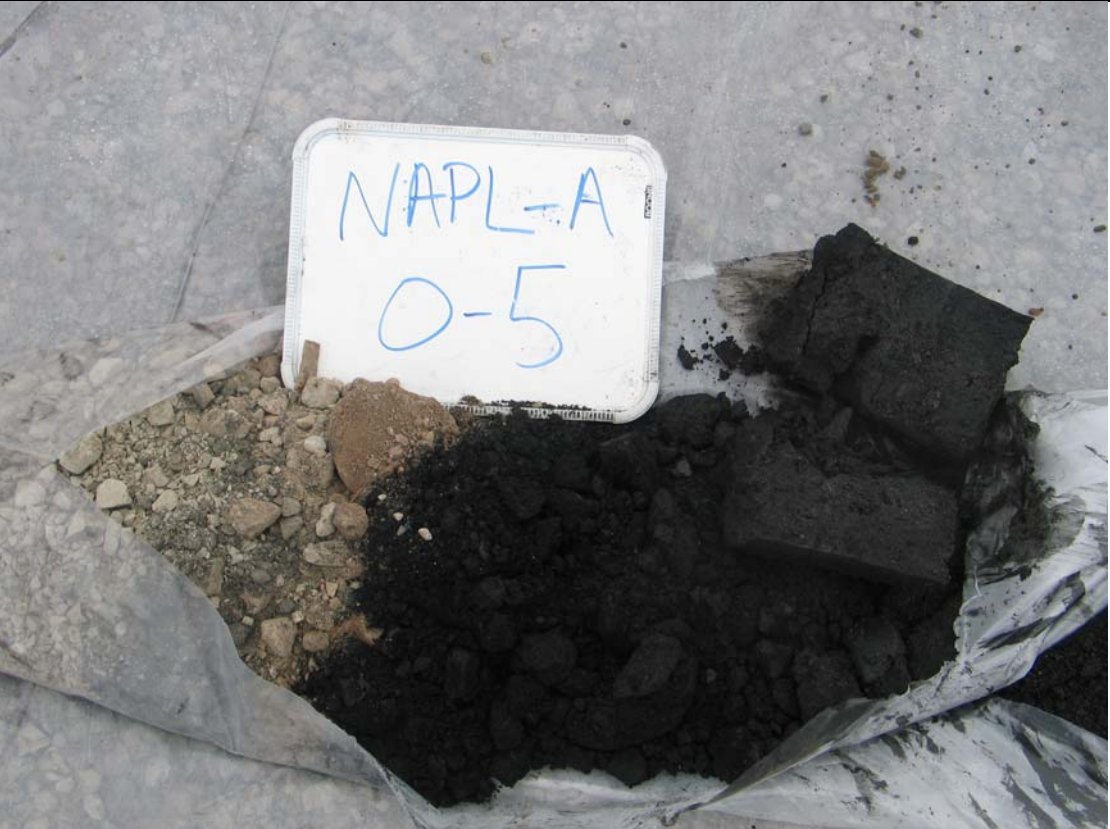
Client Name: Sauget Area 2 Sites Group		Site Location: Sauget, Illinois	Project No. 21561683
Photo No. 1	Date: 5/10/06

Description: NAPL-A (0-5')

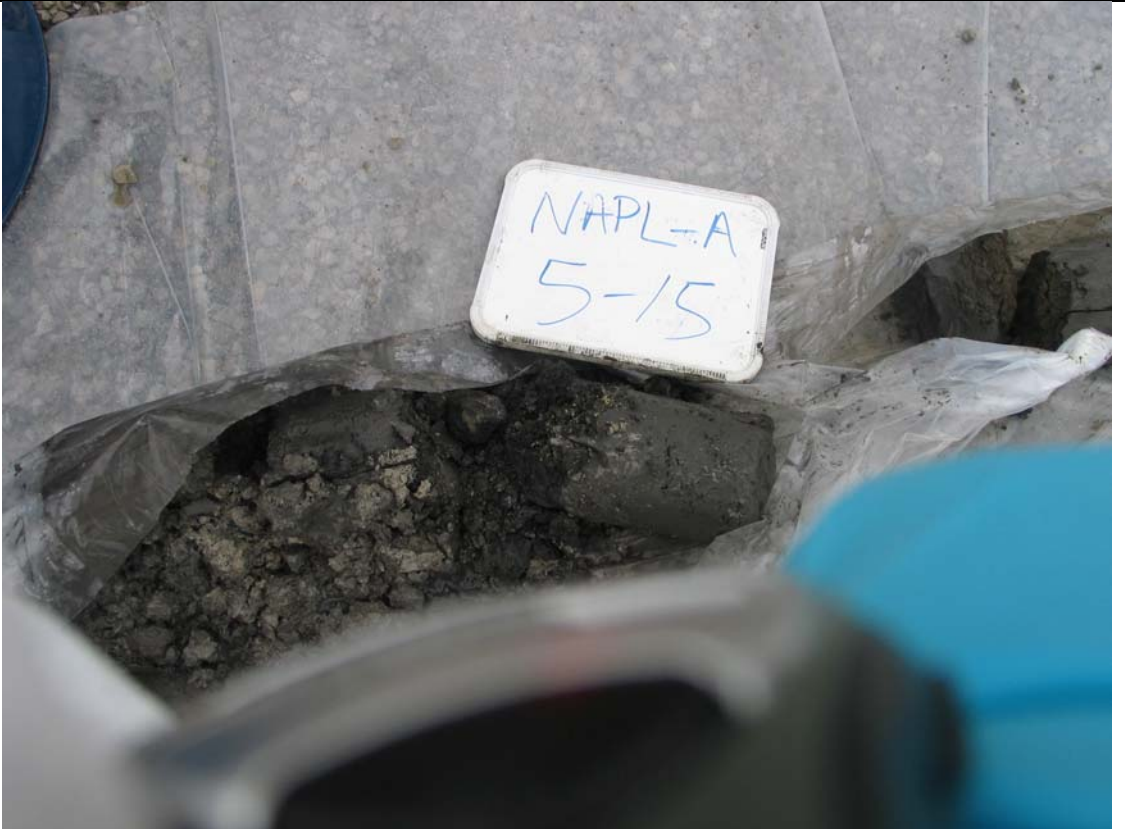
Client Name: Sauget Area 2 Sites Group		Site Location: Sauget, Illinois	Project No. 21561683
Photo No. 3	Date: 5/10/06

Description: NAPL-A (5-15')

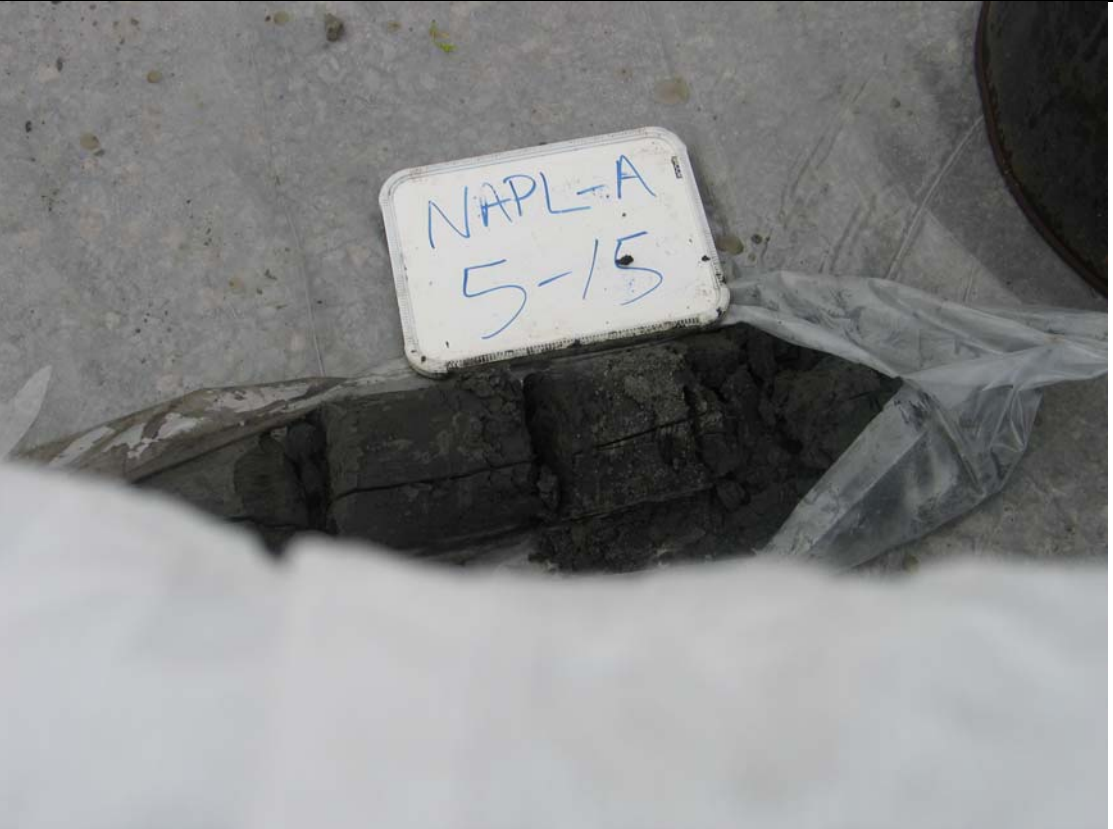
Client Name: Sauget Area 2 Sites Group		Site Location: Sauget, Illinois	Project No. 21561683
Photo No. 5	Date: 5/10/06

A photograph showing a dark, moist soil sample contained within a clear plastic bag. A white rectangular label with blue handwritten text "NAPL-A" and "5-15" is placed on top of the soil. The background is a light-colored, textured surface.	
Description: NAPL-A (5-15')

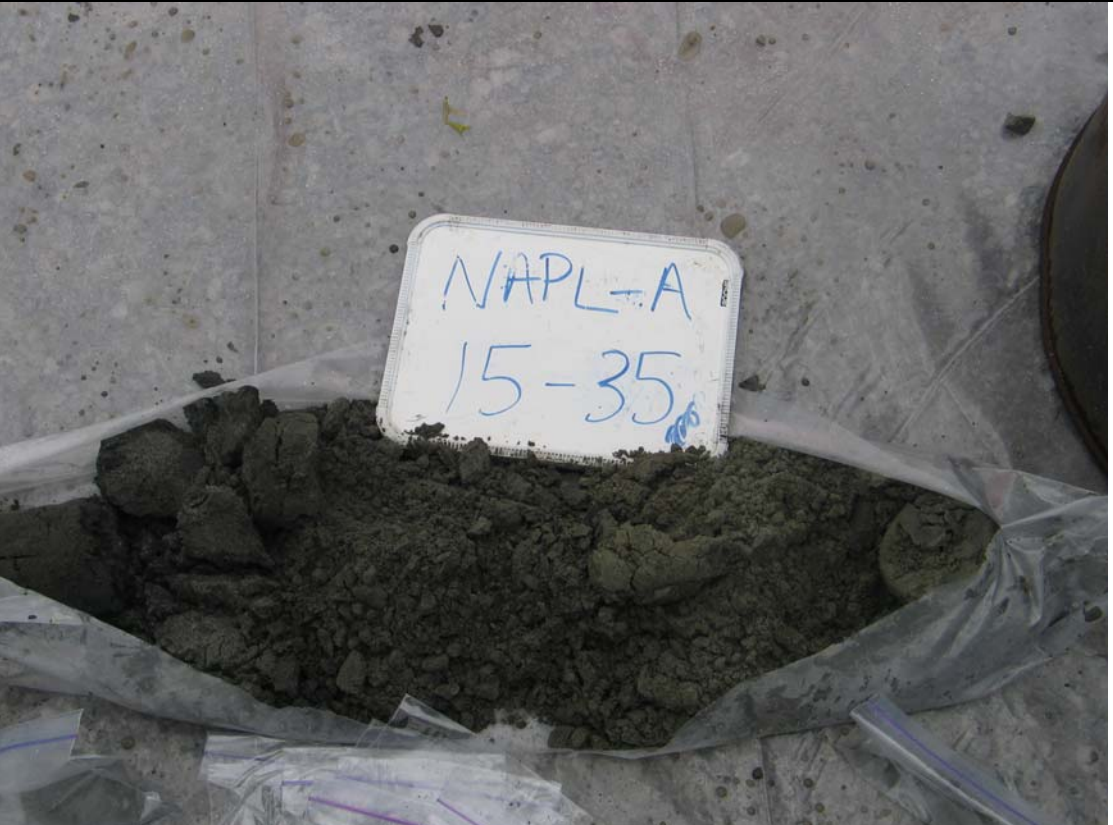
Photo No. 6	Date: 5/10/06

A photograph showing a dark, moist soil sample contained within a clear plastic bag. A white rectangular label with blue handwritten text "NAPL-A" and "15-35" is placed on top of the soil. The background is a light-colored, textured surface.
Description: NAPL-A (15-35')
